Preliminary Hand-Held Air Monitoring Locations | ITC Deer Park Tank Fire

Reading Date

3/28/2019 5:00:00 AM to 3/28/2019 6:00:00 AM

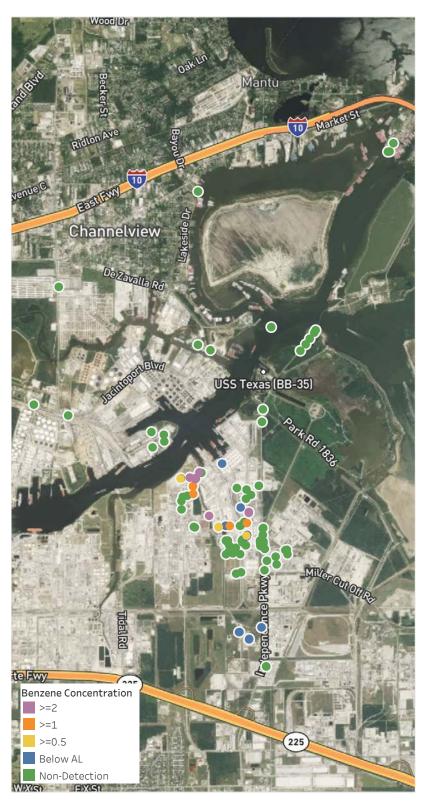
Recent Benzene Detections

Location Category	Reading Date	Concentration
Division E	3/28/2019 05:59:23	3.040 ppm
	3/28/2019 05:57:35	1.190 ppm
	3/28/2019 05:56:59	1.110 ppm
	3/28/2019 05:54:51	4.530 ppm
	3/28/2019 05:53:22	0.350 ppm
	3/28/2019 05:48:44	0.280 ppm
	3/28/2019 05:47:18	0.190 ppm
	3/28/2019 05:44:47	0.150 ppm
	3/28/2019 05:33:24	2.000 ppm
	3/28/2019 05:31:41	0.900 ppm
	3/28/2019 05:29:56	0.650 ppm
	3/28/2019 05:08:51	0.150 ppm
Impacted Tank Farm	3/28/2019 05:50:00	0.225 ppm
	3/28/2019 05:49:50	0.450 ppm
	3/28/2019 05:45:59	0.125 ppm
	3/28/2019 05:45:47	0.750 ppm
Industrial Area	3/28/2019 05:59:51	2.025 ppm
	3/28/2019 05:52:08	0.650 ppm
	3/28/2019 05:47:11	7.000 ppm
	3/28/2019 05:44:33	1.850 ppm
	3/28/2019 05:43:32	0.200 ppm
	3/28/2019 05:42:09	0.870 ppm
	3/28/2019 05:40:45	0.200 ppm
	3/28/2019 05:39:44	4.450 ppm
	3/28/2019 05:38:48	1.650 ppm
	3/28/2019 05:30:24	1.650 ppm
	3/28/2019 05:27:53	0.175 ppm
	3/28/2019 05:26:10	1.550 ppm
	3/28/2019 05:24:38	0.175 ppm

3/28/2019 05:17:33	2.350 ppm
	3/28/2019 05:11:39	0.150 ppm
	3/28/2019 05:07:20	0.125 ppm
	3/28/2019 05:03:15	6.975 ppm
